Water Compliance Inspection Report

Name and Location of Facility Inspected (For industrial users discharging to POTW, also include POTW name and NPDES permit number)	Entry Time/Date	Permit Effective Date
Ketchikan International Airport 1000 Terminal Way Ketchikan, AK 99901	9:00 am 8/31/15	4/1/2015
	Exit Time/Date	Permit Expiration Date

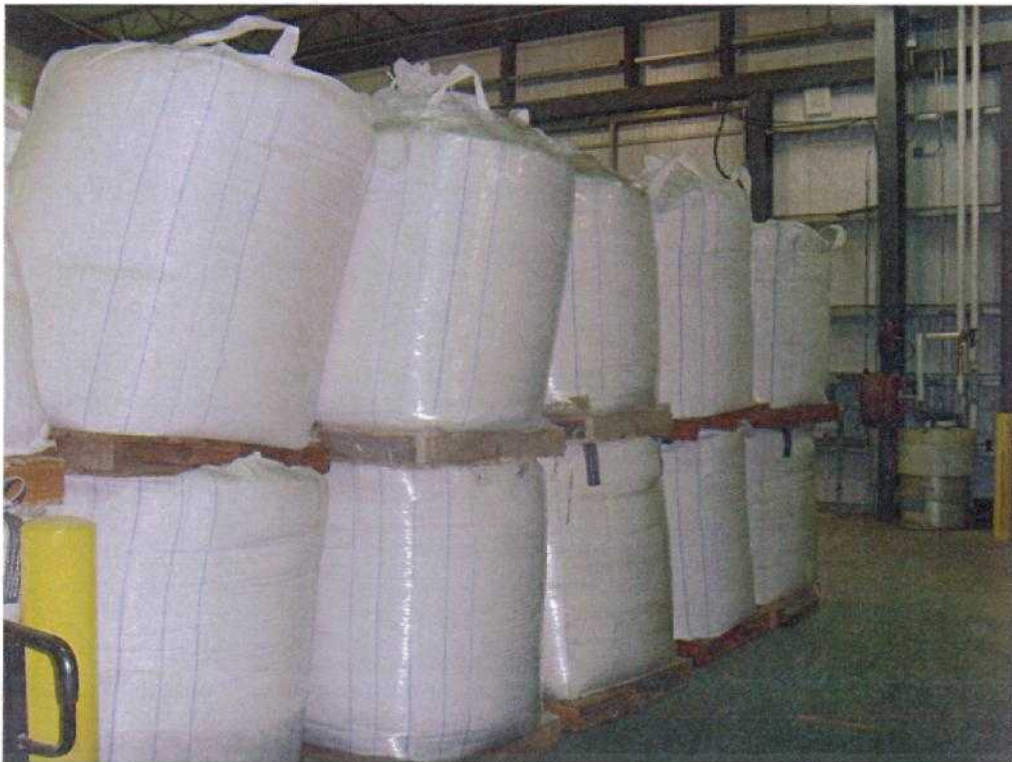
Photo 5 (SI850028): Sacks of dry urea used to make deicing solution stored inside the SRE building.

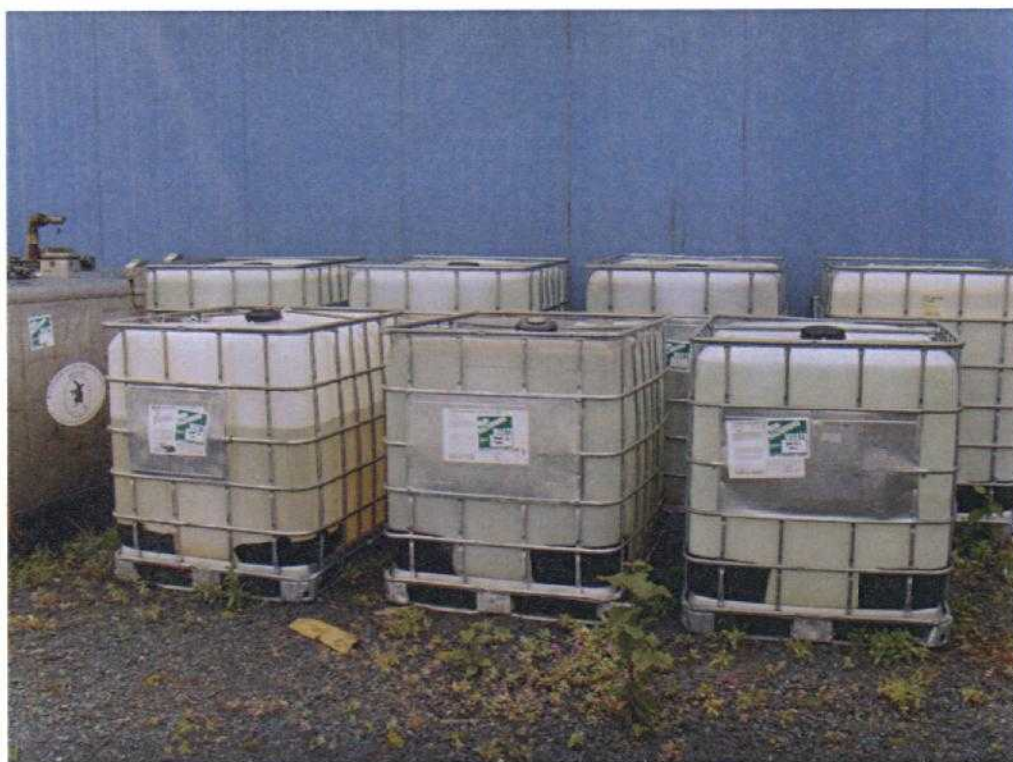
Photo 6 (SI850030): Totes containing 3% urea solution stored on the northeast side of the SRE building.

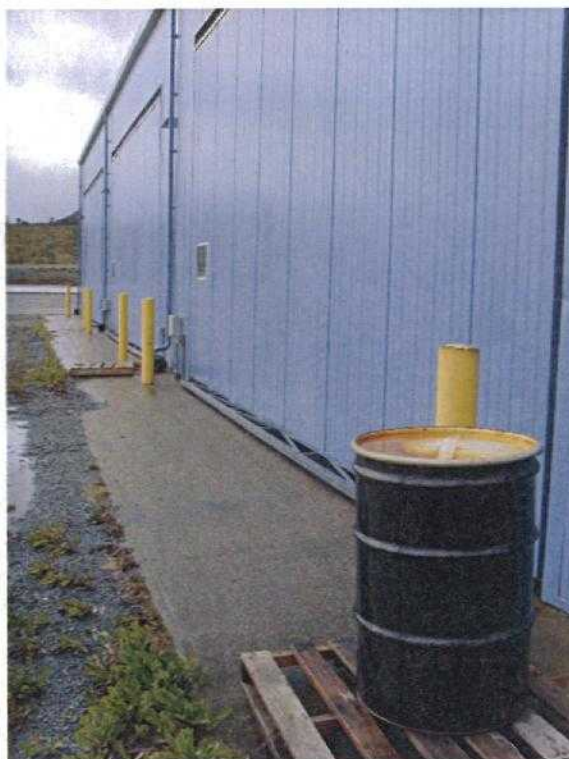
Photo 7 (SI850032): 55-gallon drum of antifreeze for the airport ferry stored outside without secondary containment at the east corner of the SRE building.

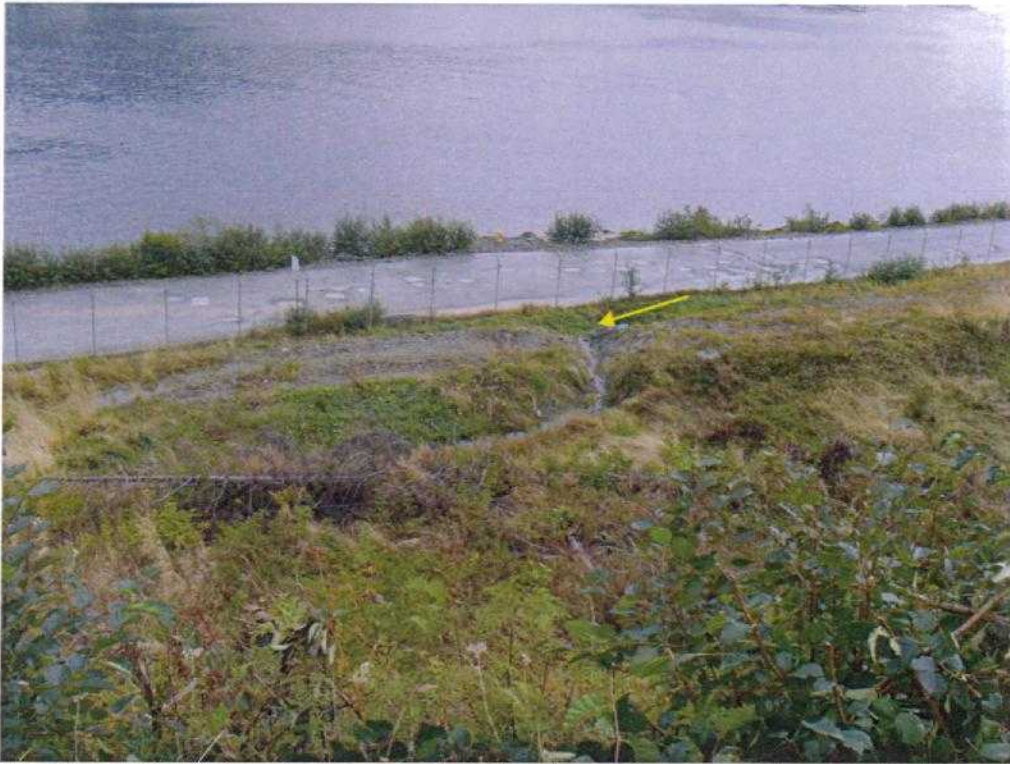
Photo 8 (SI850033): Stormwater drainage on the embankment to the east of the SRE building flowing to the Tongass Narrows. According to Mr. Langkau, some of the runoff from the yard on the east side of the SRE building flows down the embankment and enters a culvert that discharges outside the KIA fence line (yellow arrow).

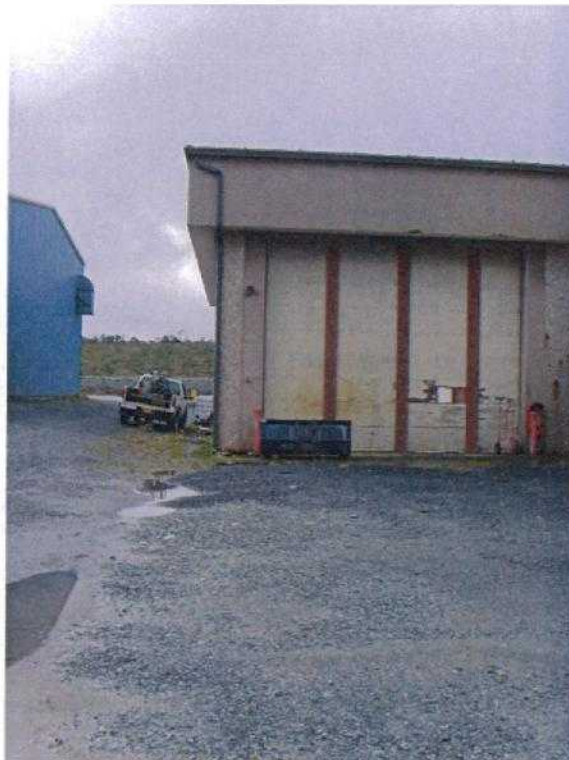
Photo 9 (SI850036): Southwestern view of the east corner of the ARFF building.

The ARFF building is separated into two areas, a vehicle maintenance shop where the facility conducts maintenance on KIA's vehicles, and an ARFF dry bay (**Photo 9**). Mr. Langkau said that the vehicle shop contains a couple of drains that route to an oil-water separator buried outside of the ARFF building and near the steep vegetated embankment (**Photos 10 & 11**). He was not sure if the oil-water separator discharges, but said he suspected that it does discharge and drainage ultimately flows down the embankment. Page 5 of the SWPPP says that the drains from the vehicle shop discharge under the gravel fill to the east of the ARFF building (**Attachment C**).

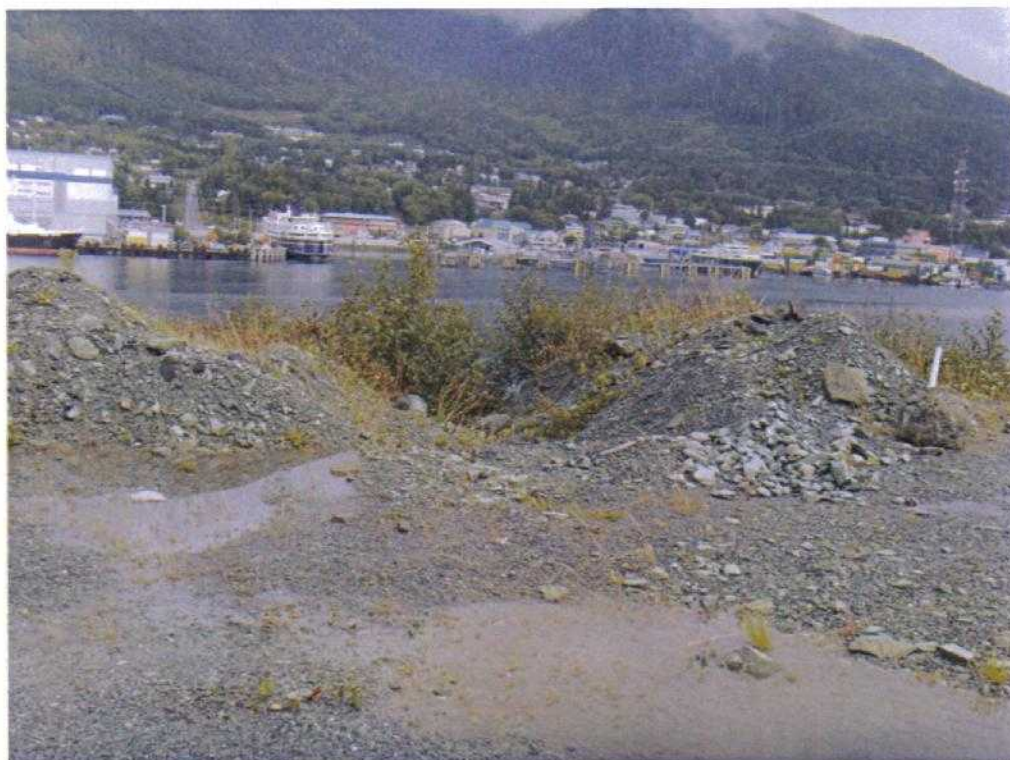
Photo 10 (SI850037): Location of an oil-water separator near the east corner of the ARFF building. Mr. Langkau said that drainage from the vehicle shop bays inside the ARFF building are routed to the oil-water separator, but he was not sure if this drainage discharges from the oil-water separator. He said that they may discharge down the embankment and into the Tongass Narrows.

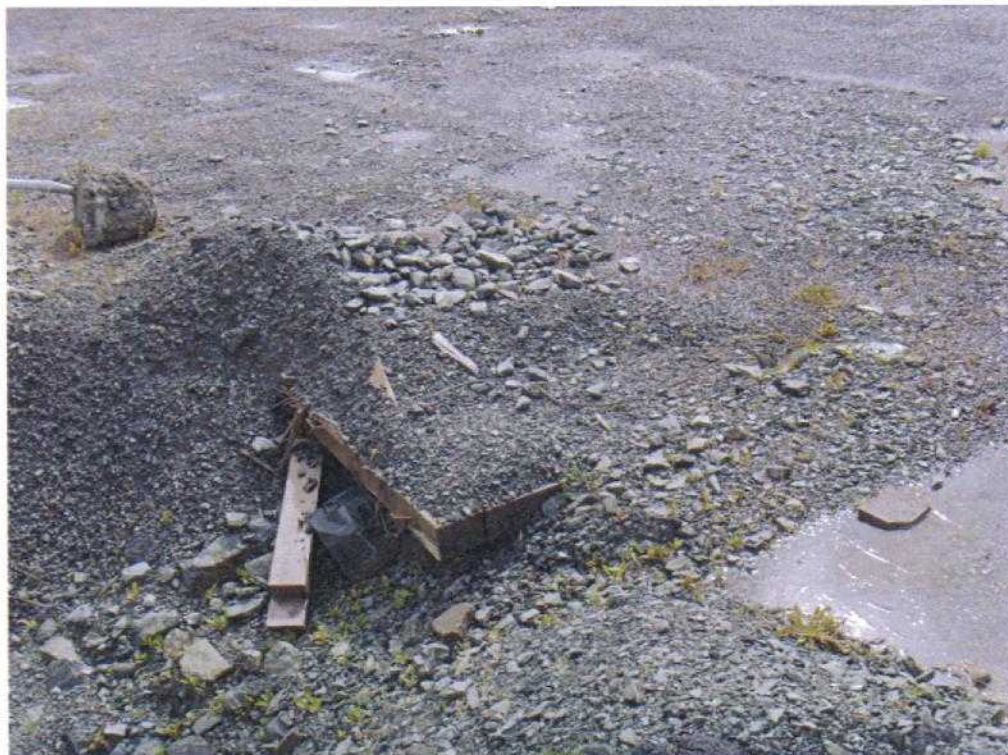
Photo 11 (SI850038): Close-up of the oil-water separator described in **Photo 10** above.

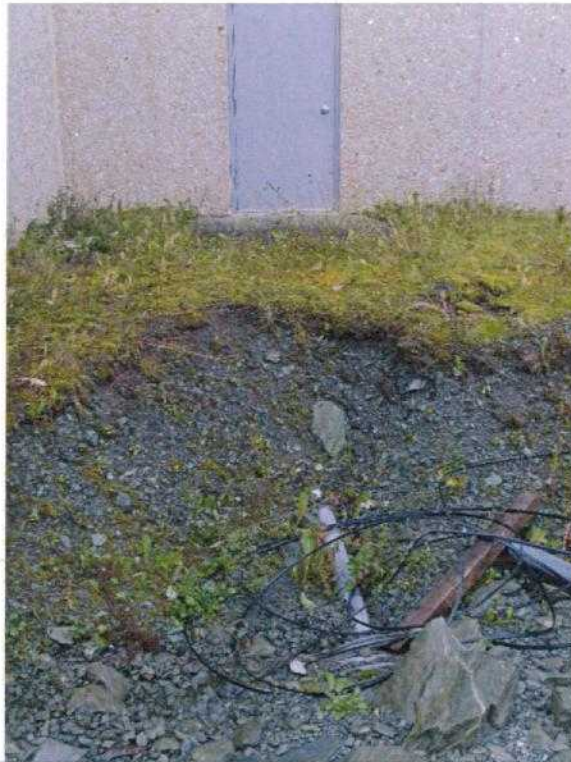
Photo 12 (SI850034): Pipe coming from the ARFF building dry bay and connecting to a larger metal pipe. According to Mr. Langkau, the larger pipe is filled in and no longer discharges. He said that no washdown or other vehicle fluids are routed through this system.

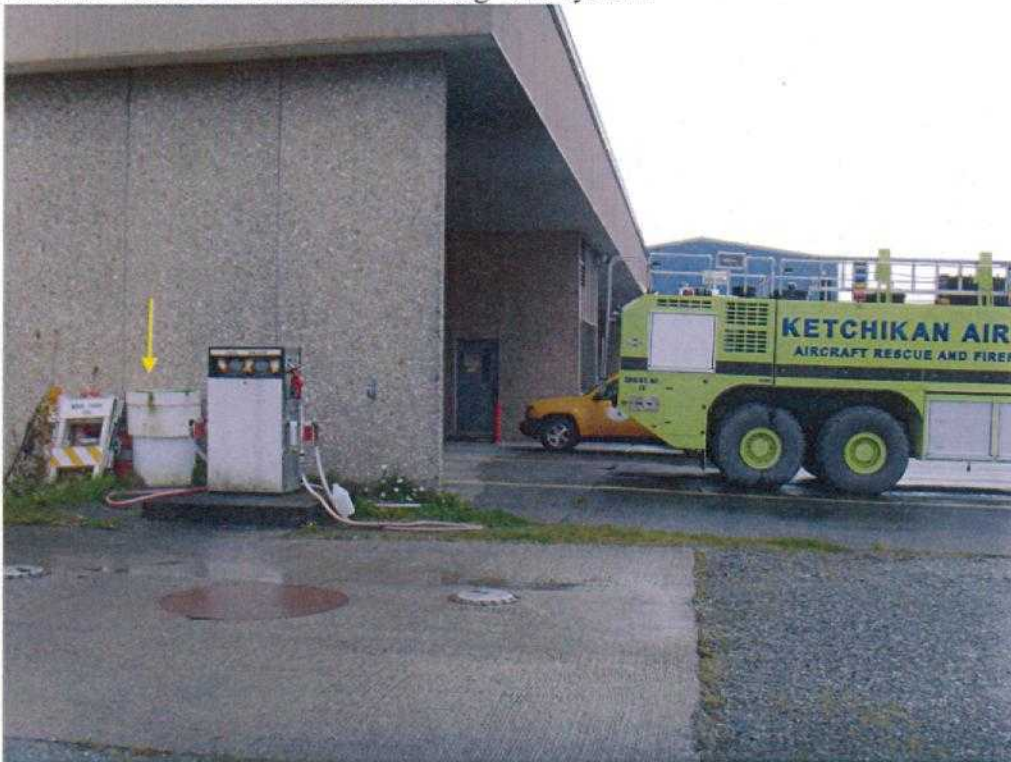
Photo 13 (SI850039): Fueling station with a spill kit (yellow arrow) located at the northwest side of the ARFF building.

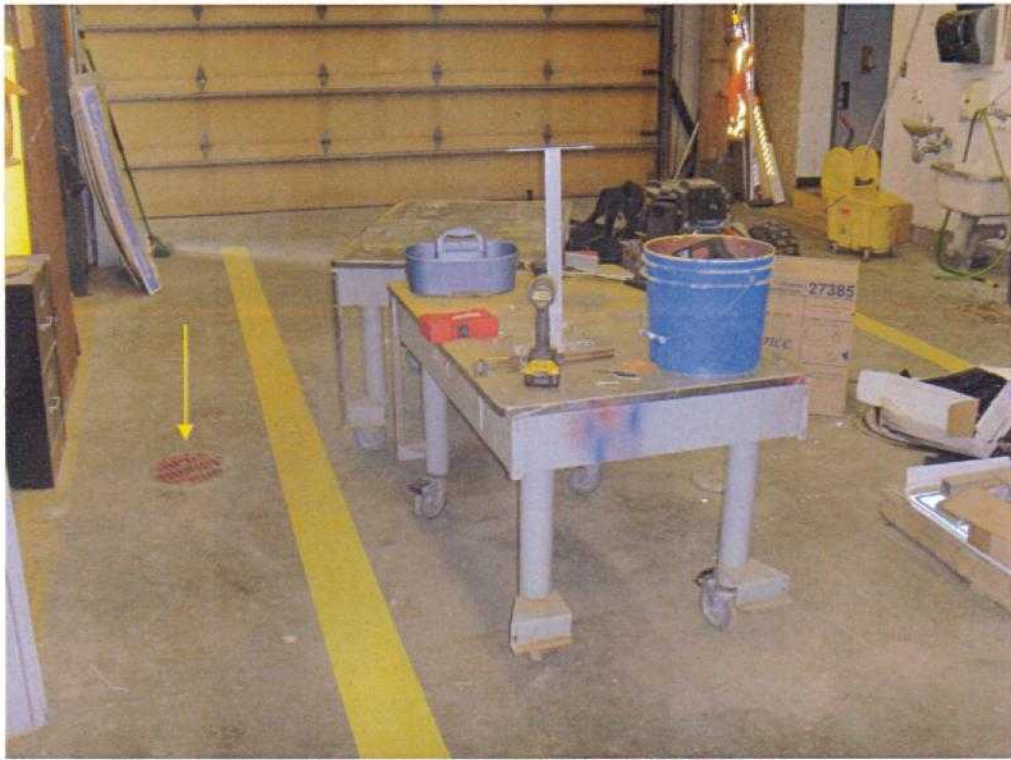
Photo 14 (SI850040): A floor drain inside the ARFF building vehicle shop (yellow arrow). According to Mr. Langkau, this drain is routed to the oil-water separator buried near the east corner of the ARFF building.

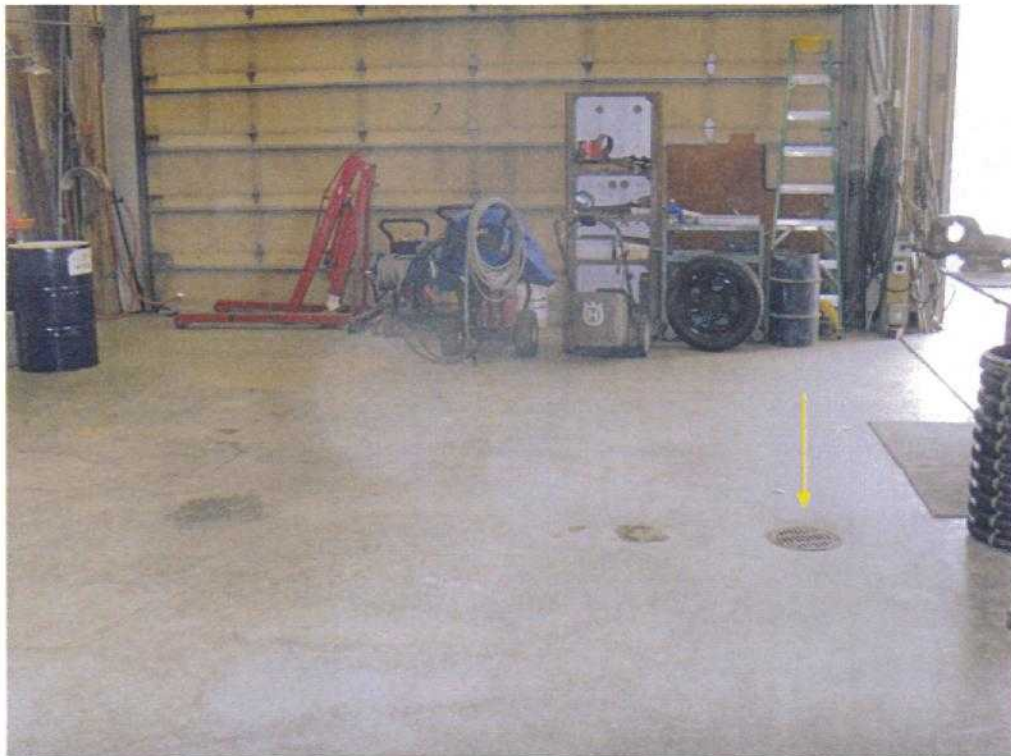
Photo 15 (SI850042): A floor drain inside the ARFF building vehicle shop (yellow arrow). According to Mr. Langkau, this drain is routed to the oil-water separator buried near the east corner of the ARFF building.

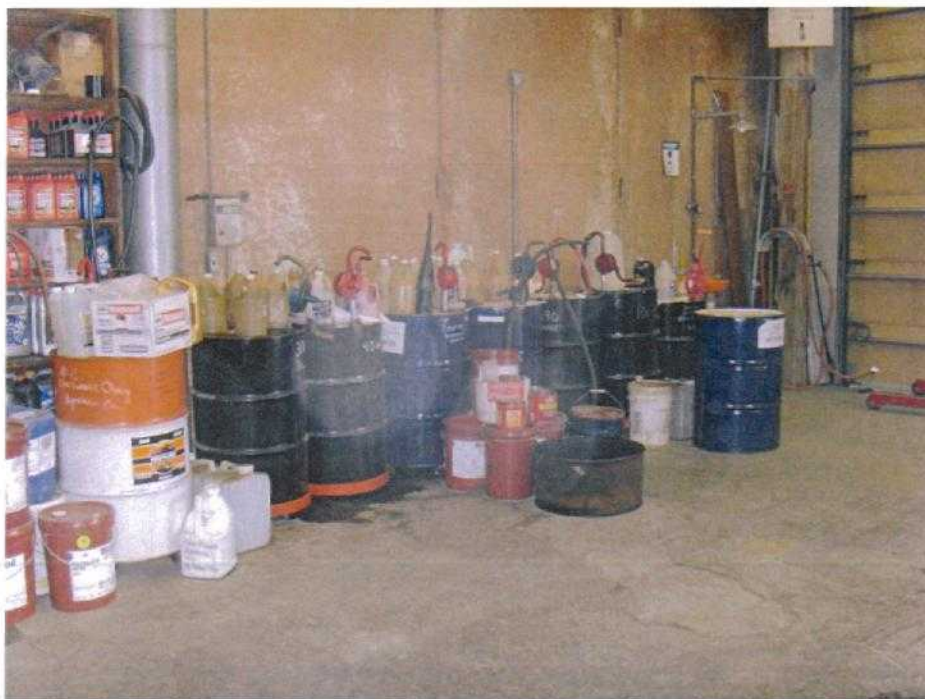
Photo 16 (SI850043): Vehicle fluids stored inside the ARFF building maintenance area in proximity to the floor drain shown in **Photo 15**.

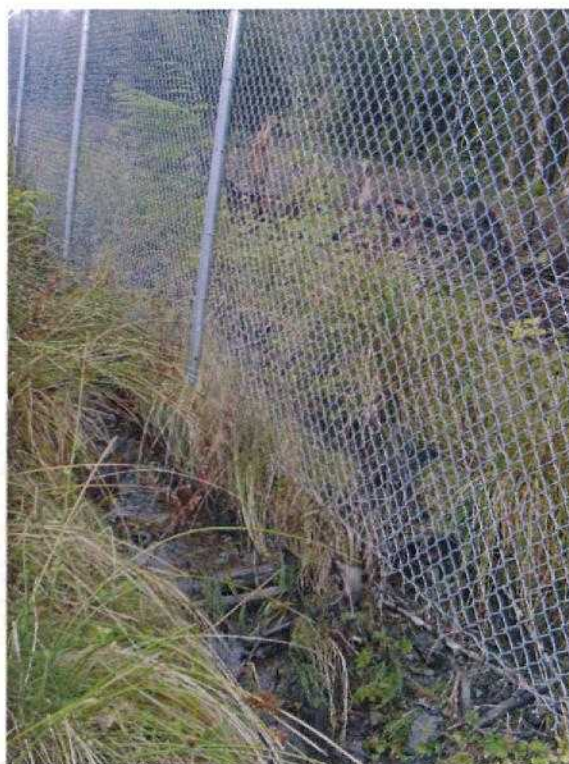
Photo 17 (SI850044): Approximate location of the outfall A sampling location.

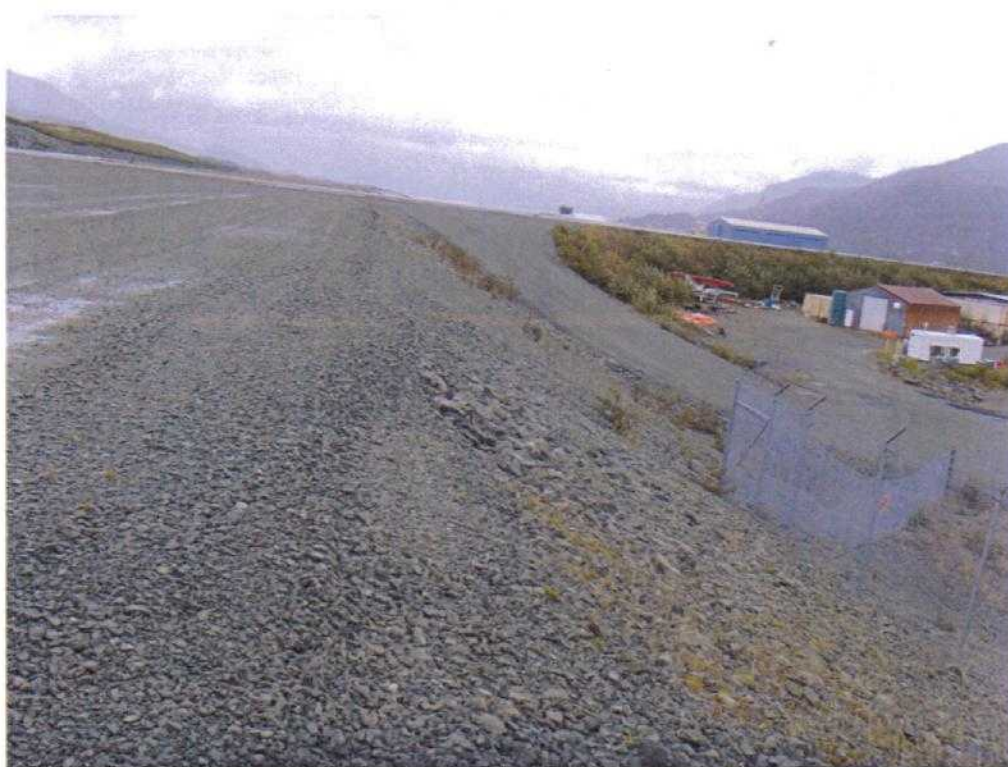
We then traveled to drainage area F which contained a portion of the runway, as well as a gravel access road to two U.S. Federal Aviation Administration (FAA) buildings (**Photo 18**). Mr. Langkau said that this was the only drainage area that is not sampled due to the fact that stormwater infiltrates into the gravel and vegetation in this area, and there are no storm drains, culverts, ditches, or other discrete conveyance systems for stormwater. He said that the FAA buildings only store dry materials such as signage.

Photo 18 (SI850045): Northwestern view of the runway in drainage area F. Mr. Langkau said that there is not a discrete conveyance of stormwater in this drainage area and the stormwater infiltrates. Two FAA buildings are located on the gravel parking area on the right side.

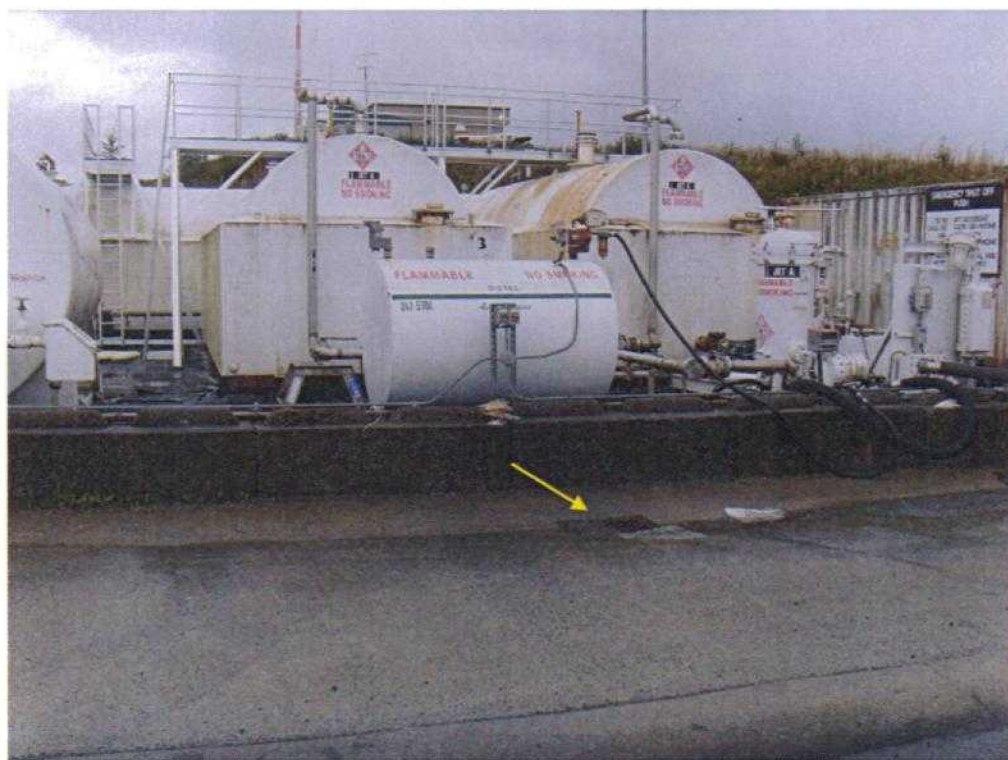
Photo 19 (SI850050): Eastern view of the Aeroservices tank farm. Note the storm drain next to the secondary containment (yellow arrow).

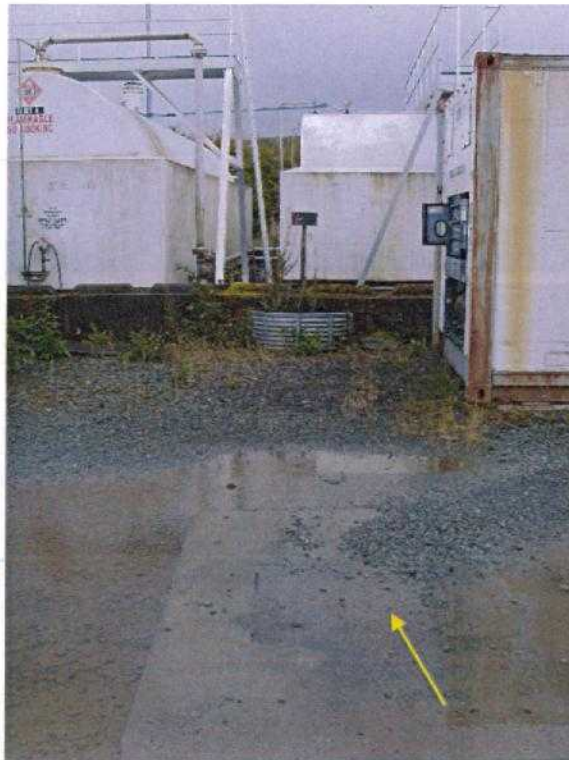
Photo 20 (SI850049): Western view of the Aeroservices tank farm. Mr. Langkau said that the lid located here was to an oil-water separator (yellow arrow).

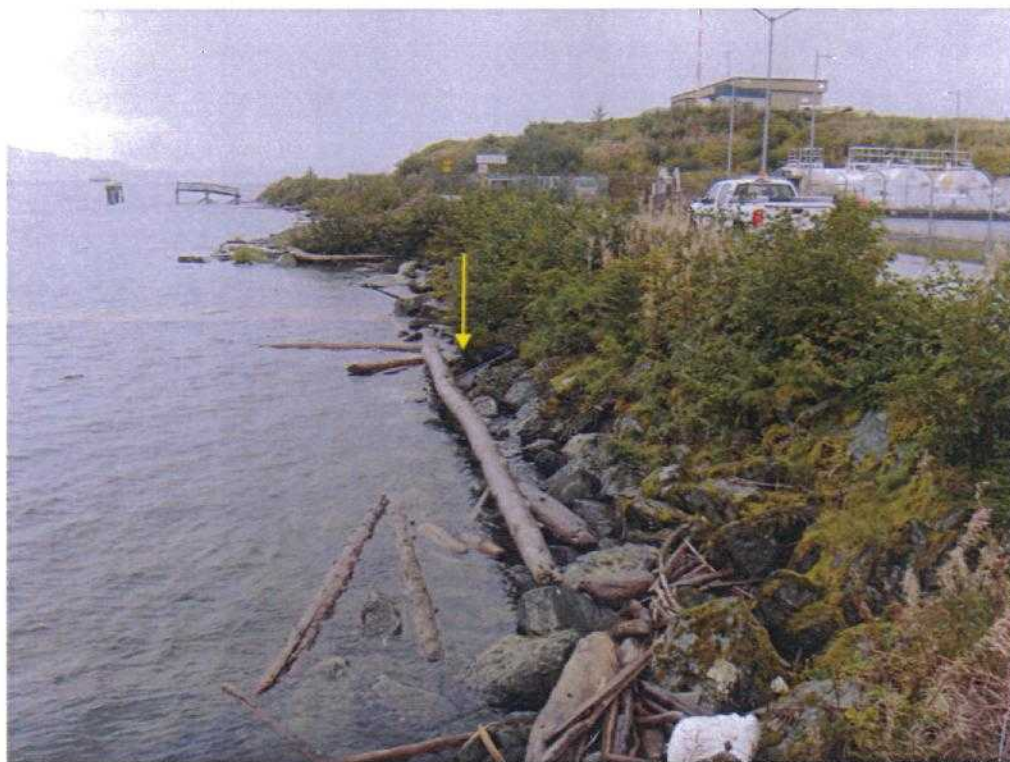
Photo 22 (SI850051): View of outfall D (yellow arrow).

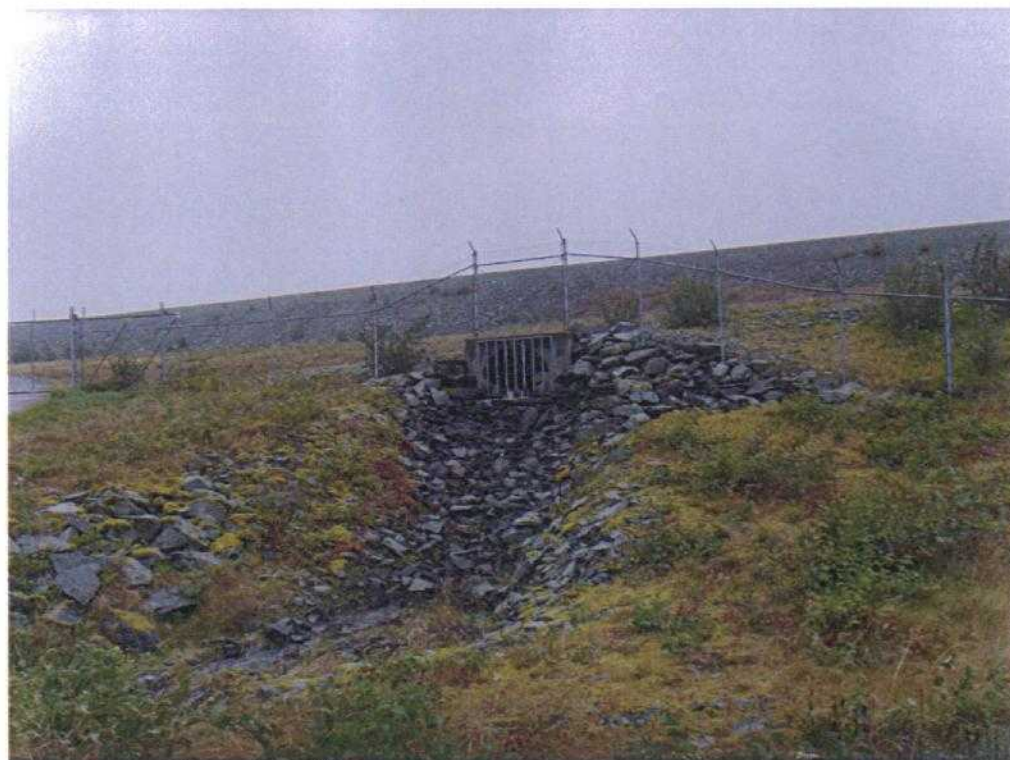
We then reviewed outfalls B and C. Drainage area B includes portions of the northwest section of the runway and taxiway. Mr. Langkau said that he samples outfall B as it exits the culvert at the KIA fence line and enters a rip rap ditch that extends to a culvert and ditch system routing to the Tongass Narrows (**Photo 23**).

Photo 23 (SI850052): View of outfall B.

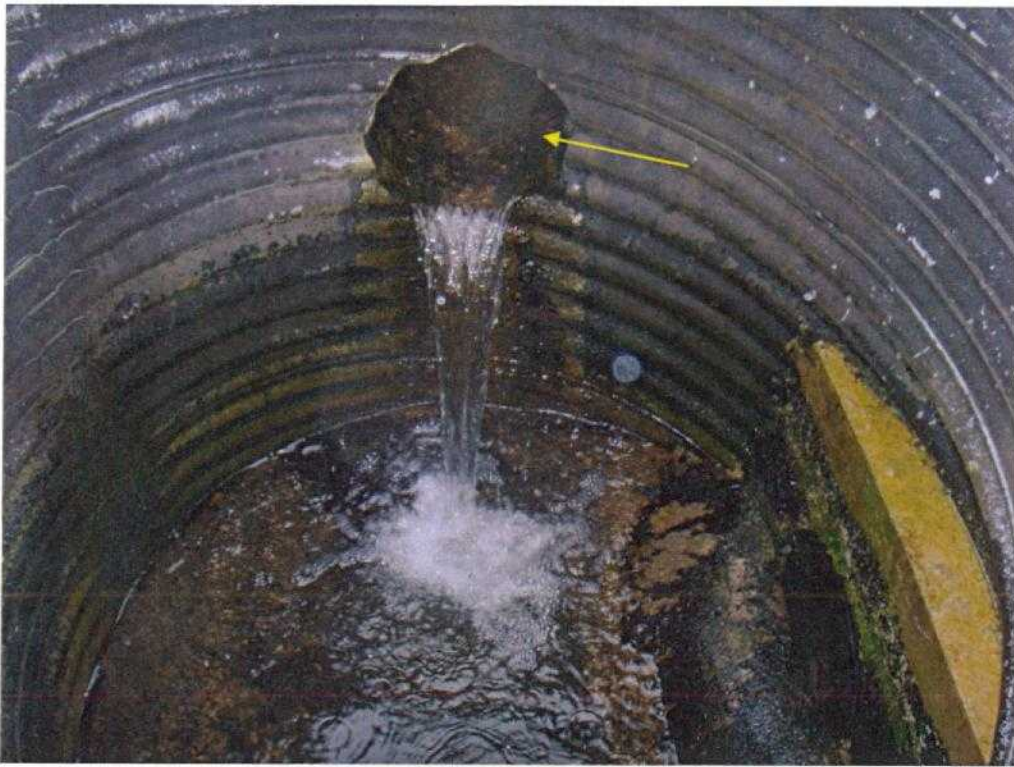
Photo 24 (SI850053): View of outfall C (yellow arrow).

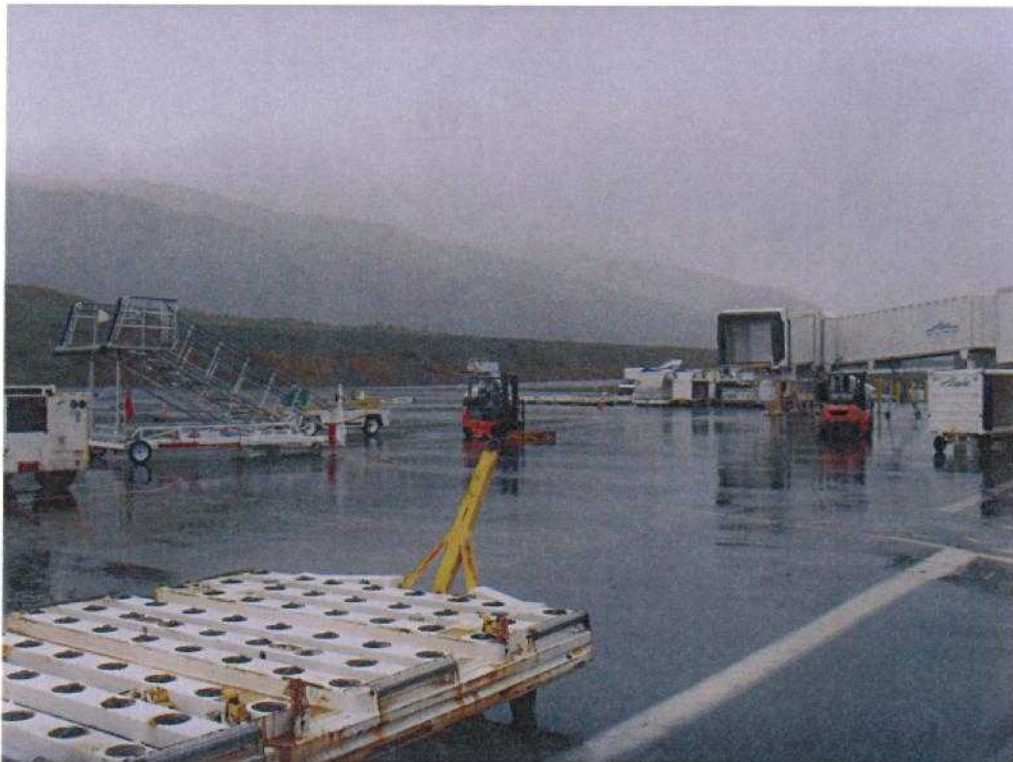
Photo 25 (SI850054): Western view of the apron next to the KIA terminal in drainage area C. Mr. Langkau said that AS operations occur in this area.
